CF6 JET ENGINE PERFORMANCE IMPROVEMENT - HIGH PRESSURE TURBINE ROUNDNESS

W.D. Howard and W.A. Fasching

GENERAL ELECTRIC COMPANY

JANUARY 1982

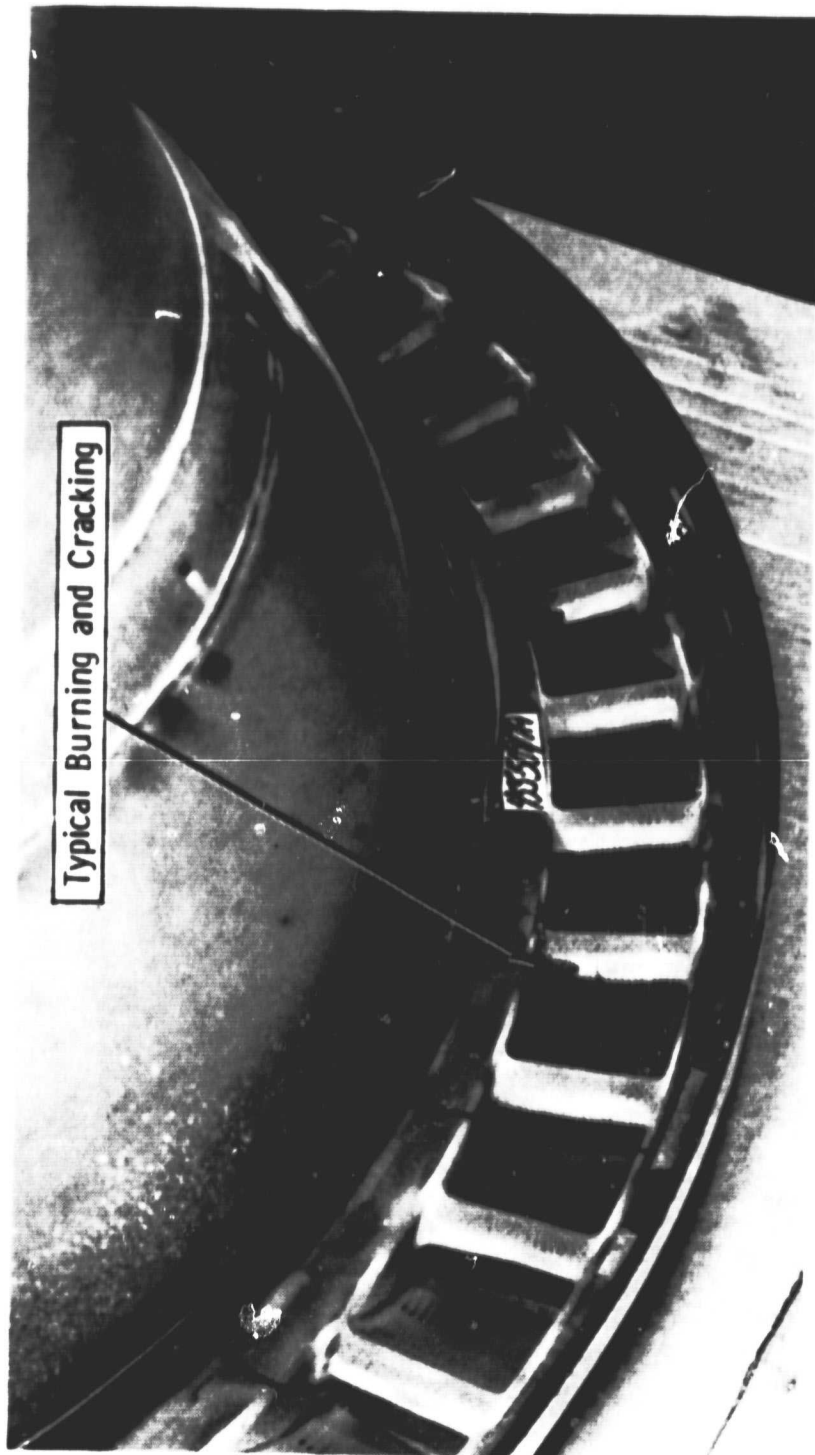
Figure 84. Front View of Stage 1 Nozzles Showing Inner Platform Burning and Cracking.

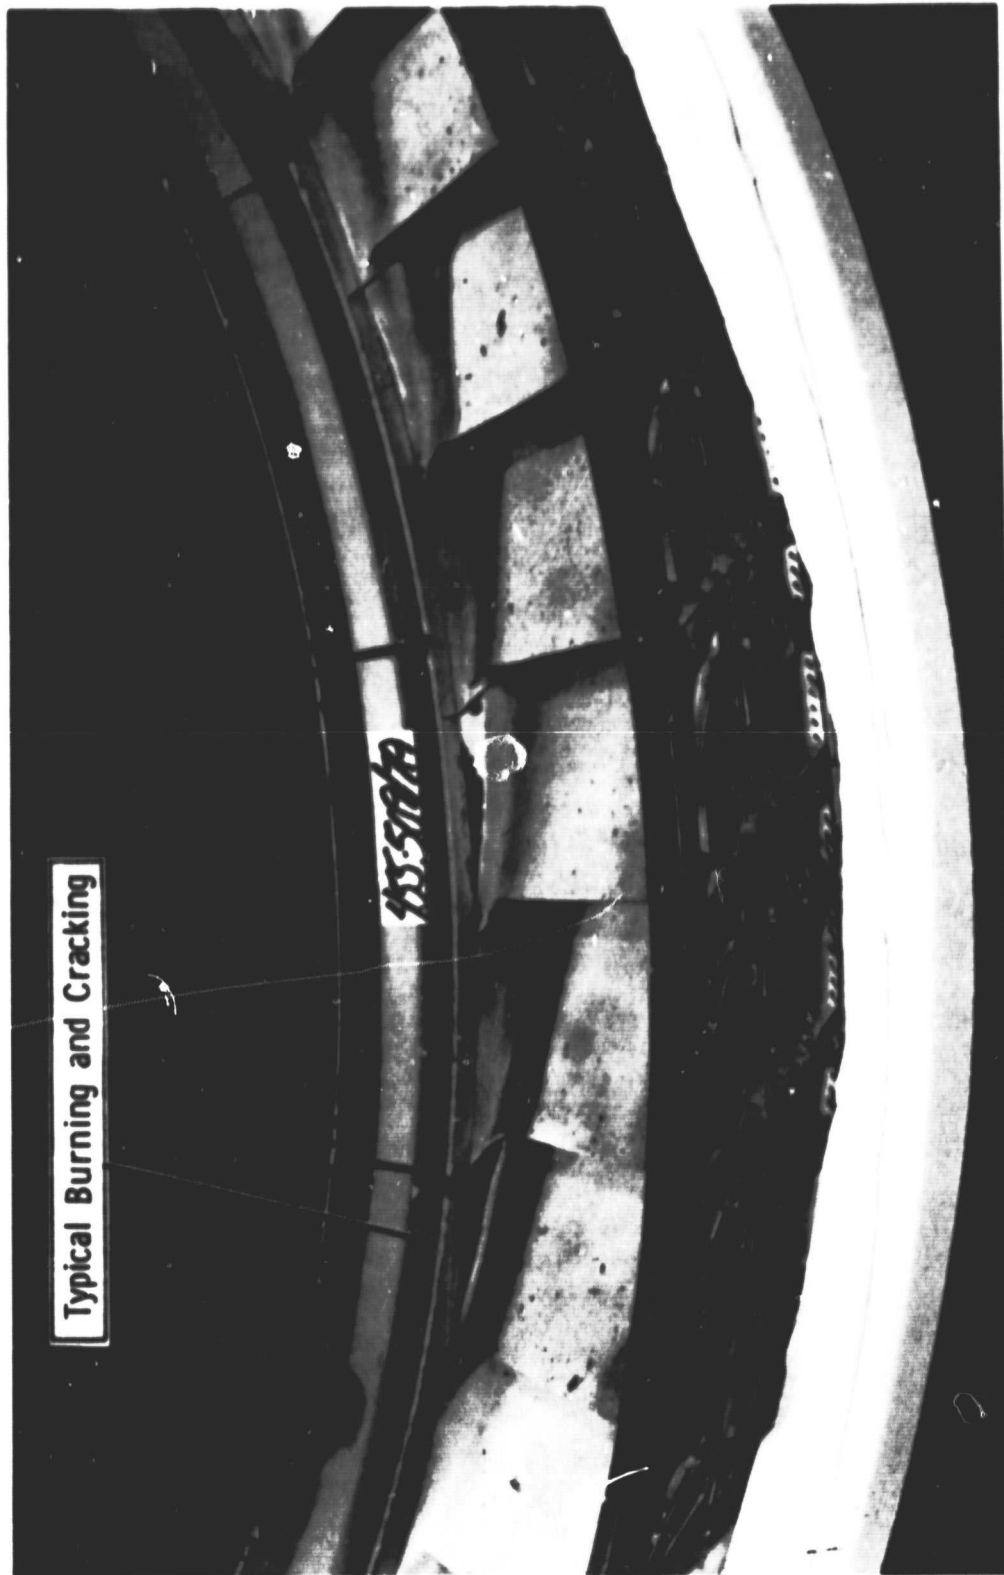
Figure 85. Aft View of Stage 1 Nozzles Showing Inner Platform
Burning and Cracking.

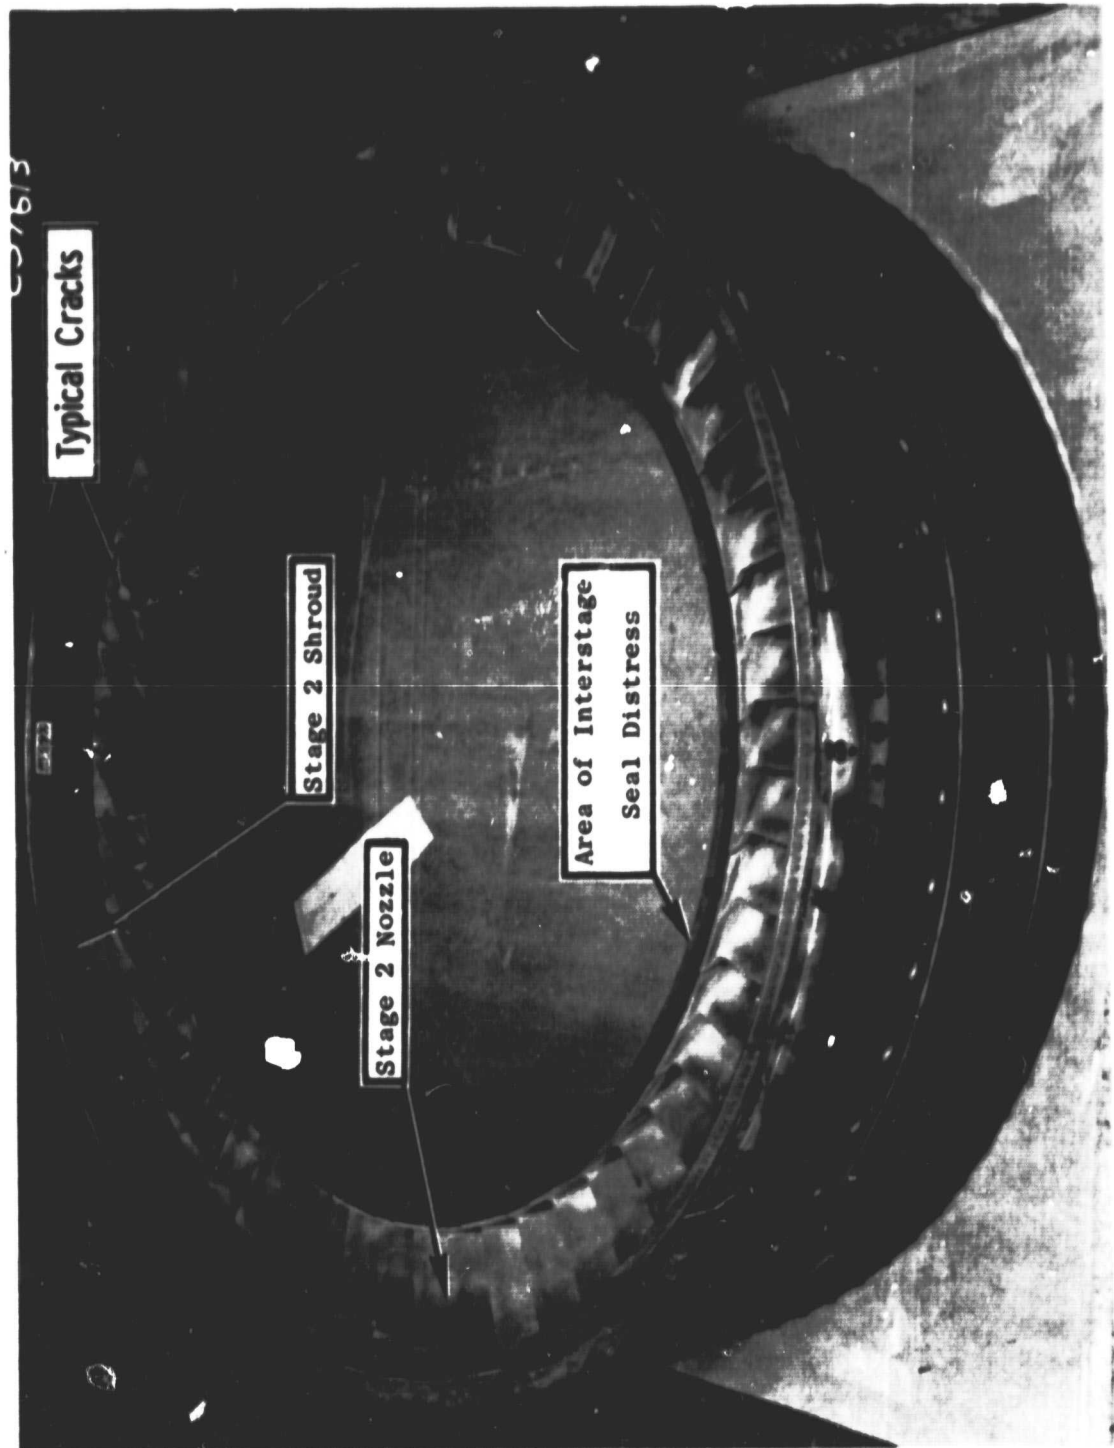
Figure 86. Aft View of Stage 2 Nozzle Assembly.

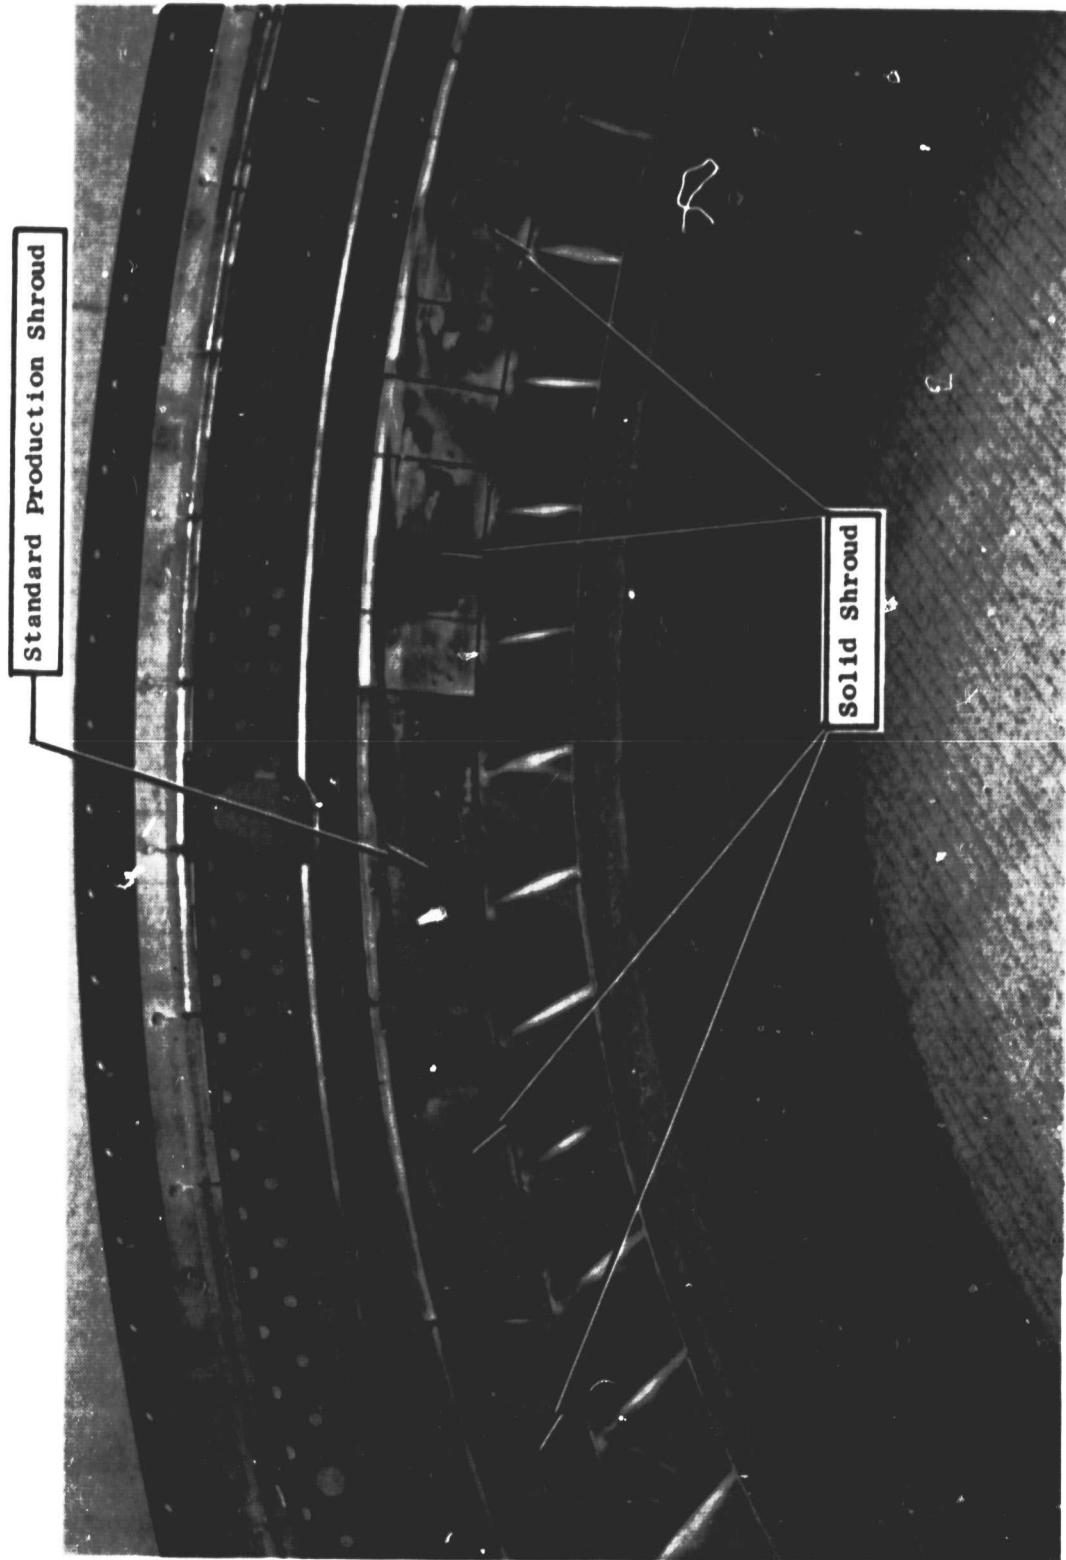
Figure 88. Stage 1 Shrouds.

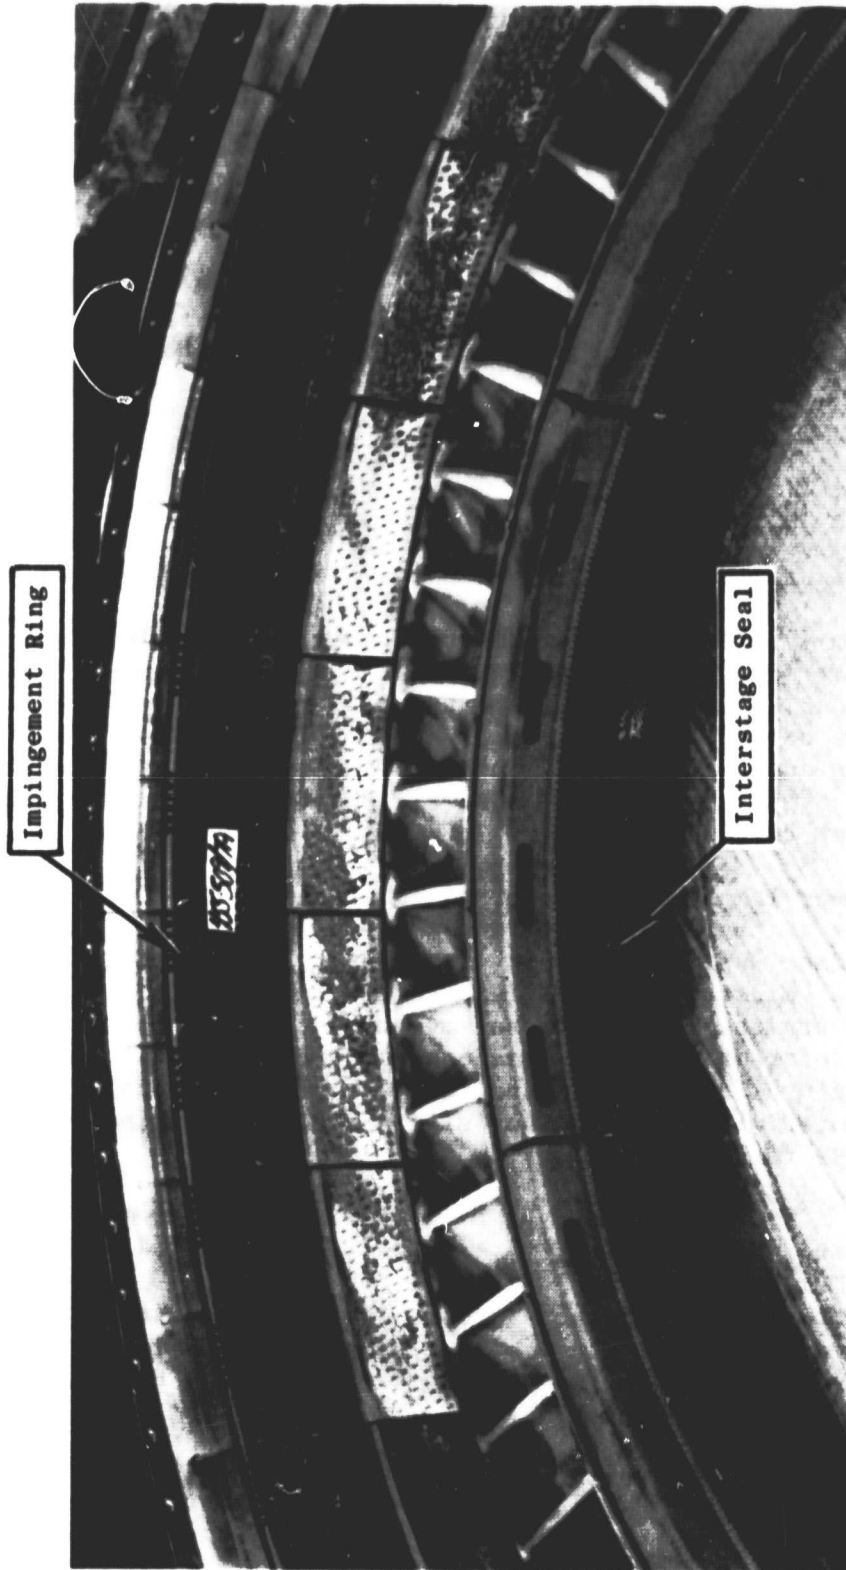
Figure 89. Forward-Looking-Aft View of Interstage Seals and Impingement Ring
Depicting Hardware Condition.

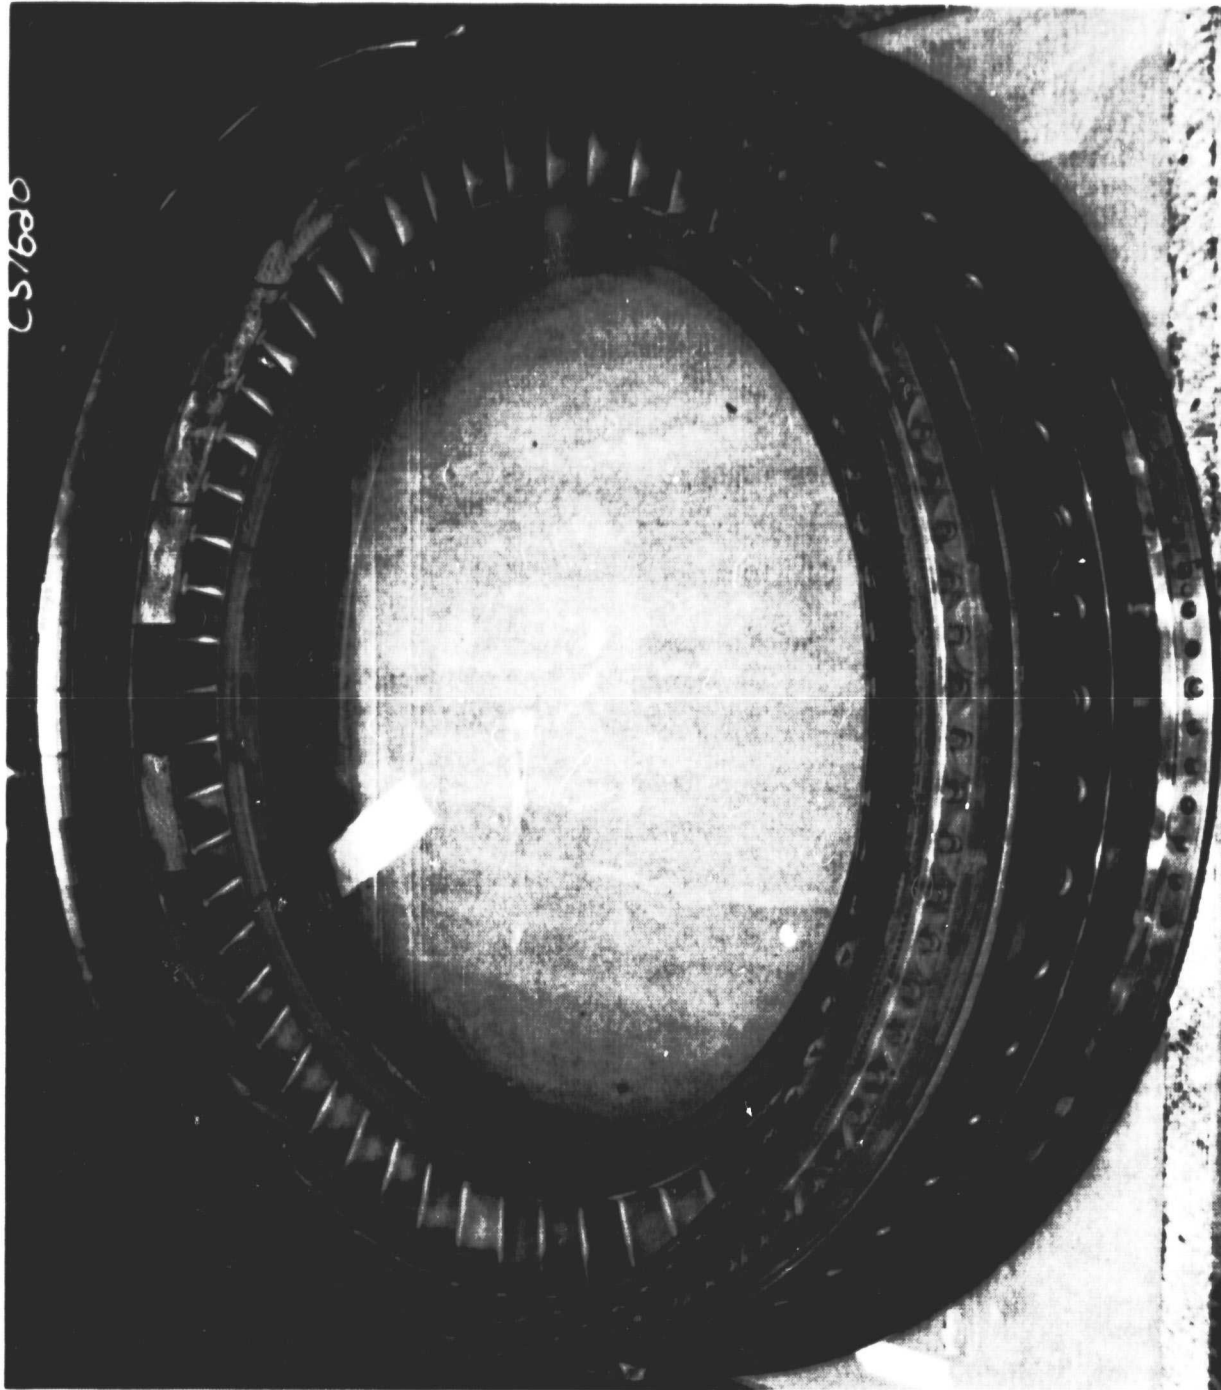
Figure 90. High Pressure Turbine Stator Stage 2 Module Assembly After
842 "C" Cycles.
